Promax Minimax Serial No 071000002535

S R Cooling

Thursday, 17 July 2014

Promax Minimax 07100002535

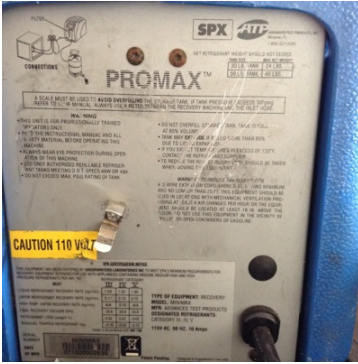
Unit tested found that fan and compressor operated however when unit was attached to test rig it became apparent that it was not recovering refrigerant.

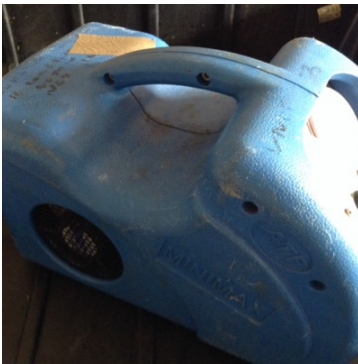
Minimax

Unit has pen markings and numerous scratches and scrapes to the casing, one of the dust caps is also missing.

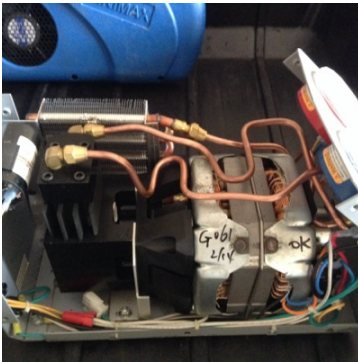
Internals

Unit is in good internal condition.

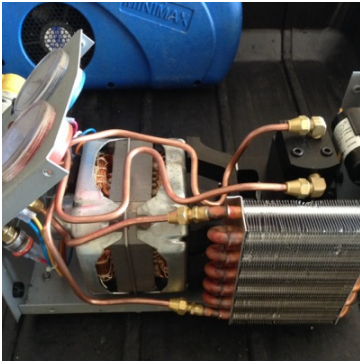
Internals 2

Internal state of unit from second side.

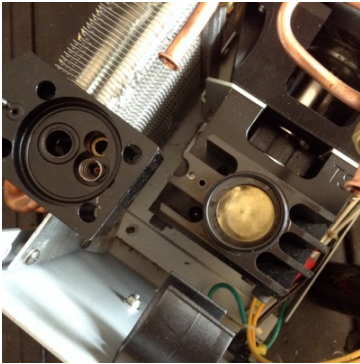
Cylinder Head Removed

Cylinder head removed to reveal head and piston in good clean condition.

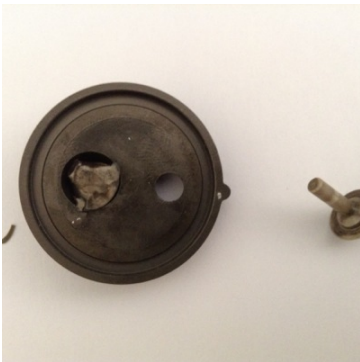
Valve Plate Damage

Upon inspection of the valve plate it became apparent that there was significant damage to the suction valve as can be seen in the picture.

Top end overhaul of compressor replacing valves, springs and valve plate.

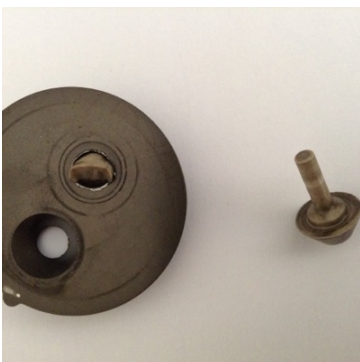
Valve Plate 2

Opposite side of valve plate again showing extent of damage.

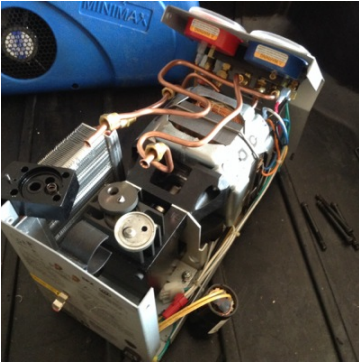
Conclusion

Overall a good used machine in very clean internal condition.

We would recommend the following repairs.
